Fishing Job for ESP Recovery

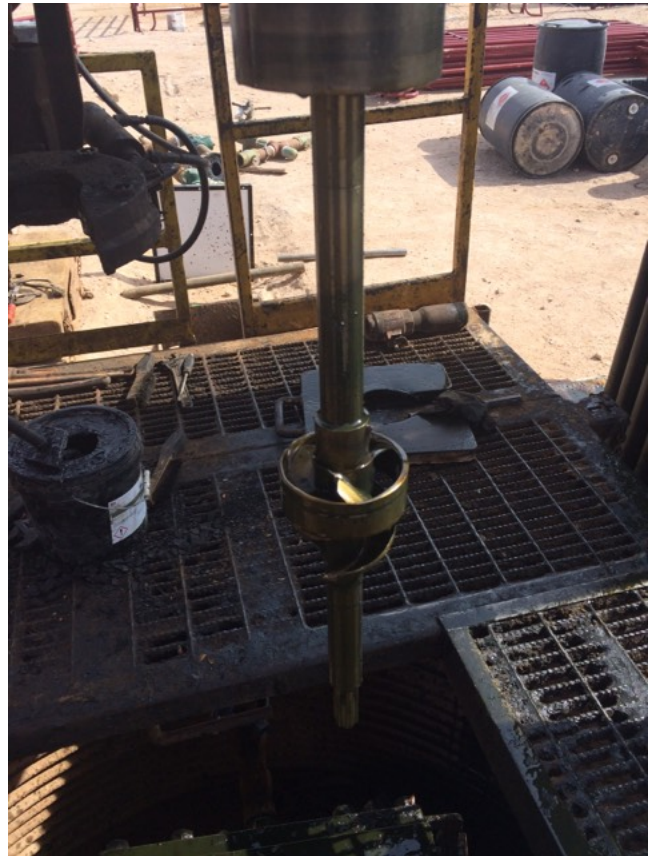
Impeller of the ESP
