Fishing Job for ESP Cable Recovery

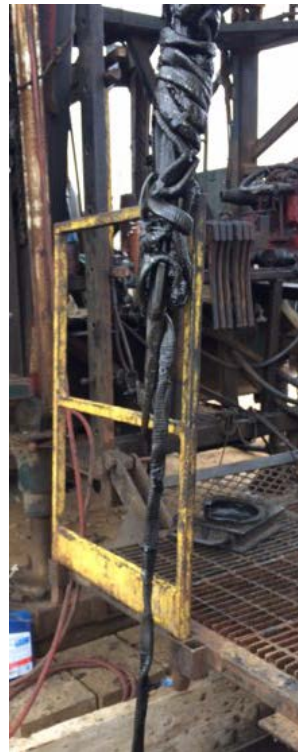
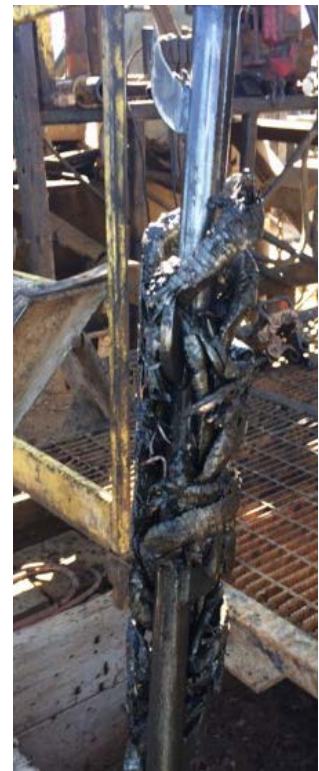
Wellsite's Permian operations team was called out to assist an operator with an ESP cable that had broken off of an ESP assembly during a tubing workover operation. The ESP cable separated from the tubing and the ESP assembly while the workover rig was pulling the tubing. The cable crimped and winded up, causing a major obstruction in the well. The operator attempted to retrieve the cable for more than a day but with minimal success.

Wellsite's team was consulted, and after a detailed review, was hired to retrieve the cable. Once on location, Wellsite's fishing supervisor briefed the applicable personnel of the retrieval plan and then initiated the execution of the operation. The ESP cable was quickly recovered and the operator was immediately back to work installing the new ESP assembly and production tubing.
